## Petrol Tank: Repairing Pin Holes and More!

...*the Pink Gag* or to be correct a Suzuki RB50 from 1986 (see image 1).

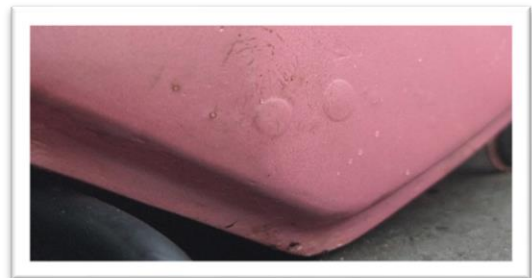
In the next image, you can see that the ethanol in the petrol has started to expand and push out the fibreglass.

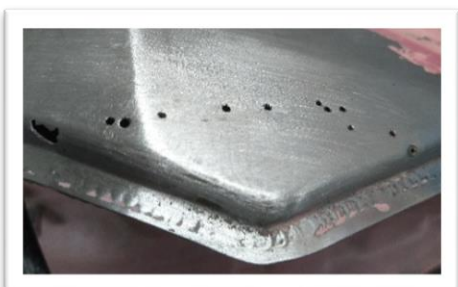
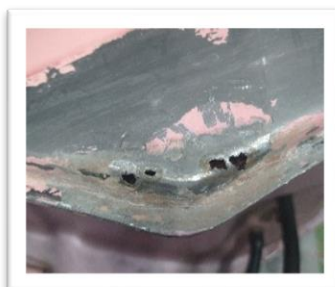
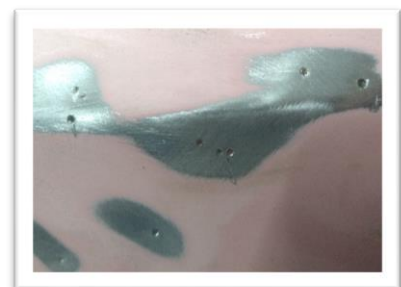
A quick rub down showed the extent of the damage on both lower edges and also the pin holes.

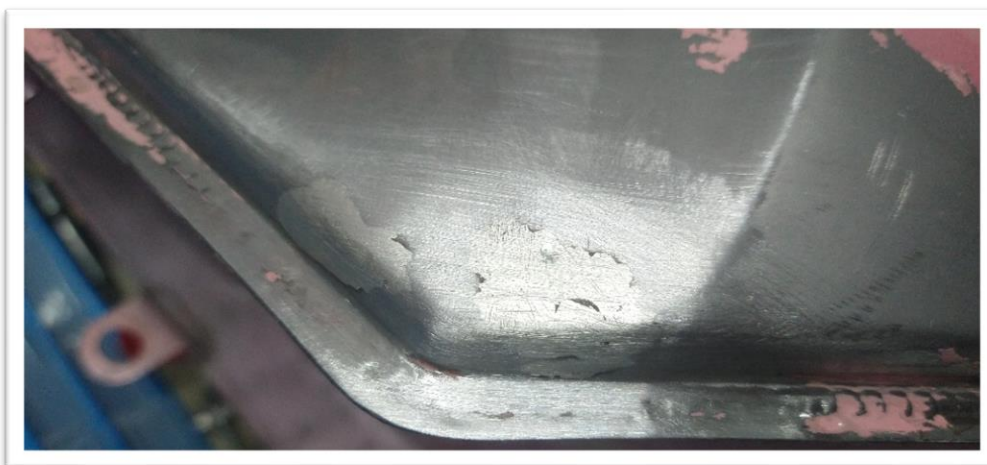
It's probably a little hard to see in these images, but I was really pleased with the result, especially as my first time trying. Below you can see the the result of the filled larger holes.
