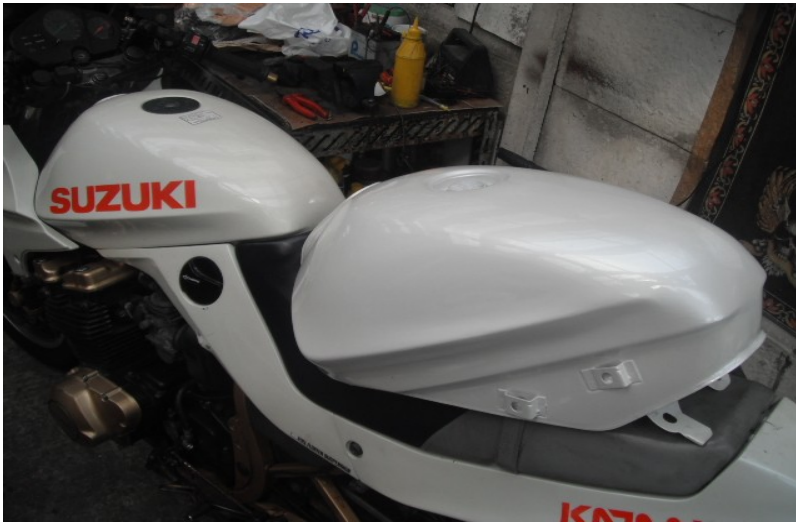
We painted the body in Toyota 070 which is available widely. To compare we had a pop-up which hadn't been repainted at all. They were indistinguishable against each other.

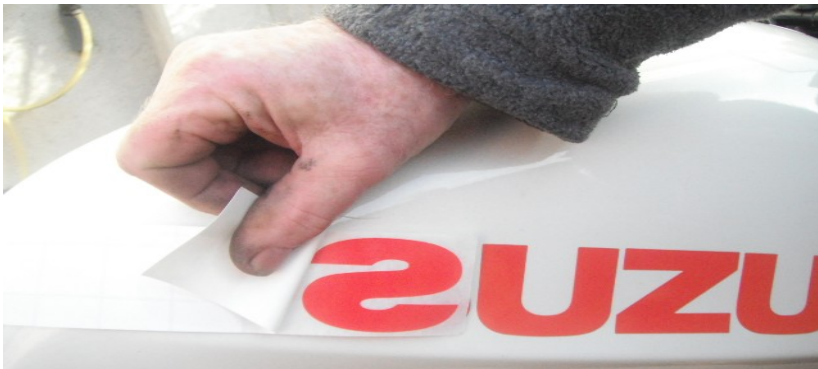
The replacement set of decals against the original set to check font and colour.

The Decals took a bit of sourcing because there are many advertised on the internet but they are of questionable quality.

To this end Classic reproductions near Matlock were used because when the first set came we compared them to our originals and noted the discrepancies in colour, font, etc. They then altered the production and sent out a new corrected set.
